# Sound solutions for the food and drink industries

Reducing noise in food and drink manufacturing

## **HSG232 (Second edition, published 2013)**

This book gives examples of simple, cost-effective ways of reducing the risk of hearing damage to workers in the food and drink industries. It contains 60 case studies showing how companies have found successful solutions to problems created by high noise levels.

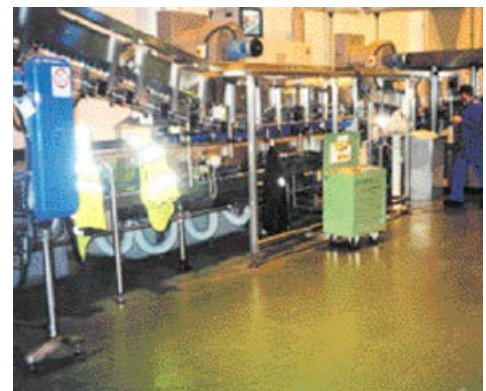
*Solution: new bottling line*

On the new line, the rinser-filler-capper machine was enclosed and there was less use of stainless-steel, which helped reduce the reverberant noise. The company also installed the line in a production hall with high ceilings to reduce the reverberant noise levels.

- The noise levels produced by the new bottling line were below 80 dB.
- The layout of the line made cleaning easier.
- The number of raised work platforms on the new line was reduced, which led to a reduction in accidents from slips, trips and falls.
- The new line was more efficient.

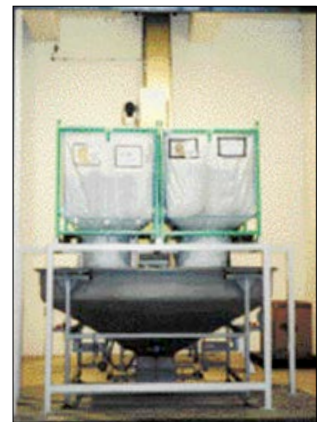
*Solution: preform hopper relocated in segregated area*

The preform storage consisted of large stainless-steel hoppers. These created a great deal of noise when preforms were loaded in, and when the hopper was delivering to the blower. The hoppers were relocated into an unmanned area. As the hoppers only needed to be visited twice daily, this reduced noise exposure considerably in the working areas.

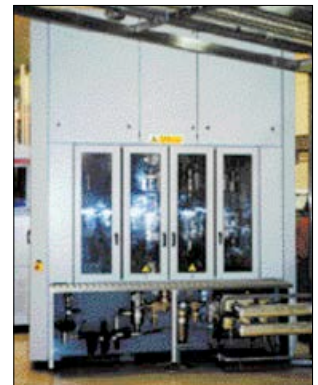
*Solution: new bay lined with acoustic panels for enclosed bottle-blowers*

- Noise levels in the new hall were below 83 dB.
- The area did not require mandatory hearing protection.
- Communication in the area improved and the area is seen as the benchmark for future developments.

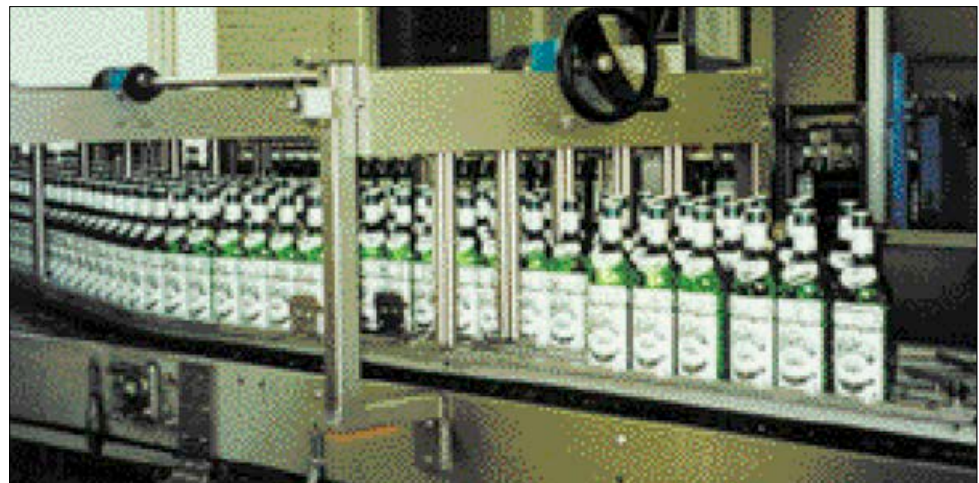
A noise survey identified the high noise levels. The company purchased a new design of conveyor in which the various chains moved at different speeds in relation to the number of bottles on the line and their progress through the machines.

*Solution: new variable-speed conveyor with adjustable guide-rails*

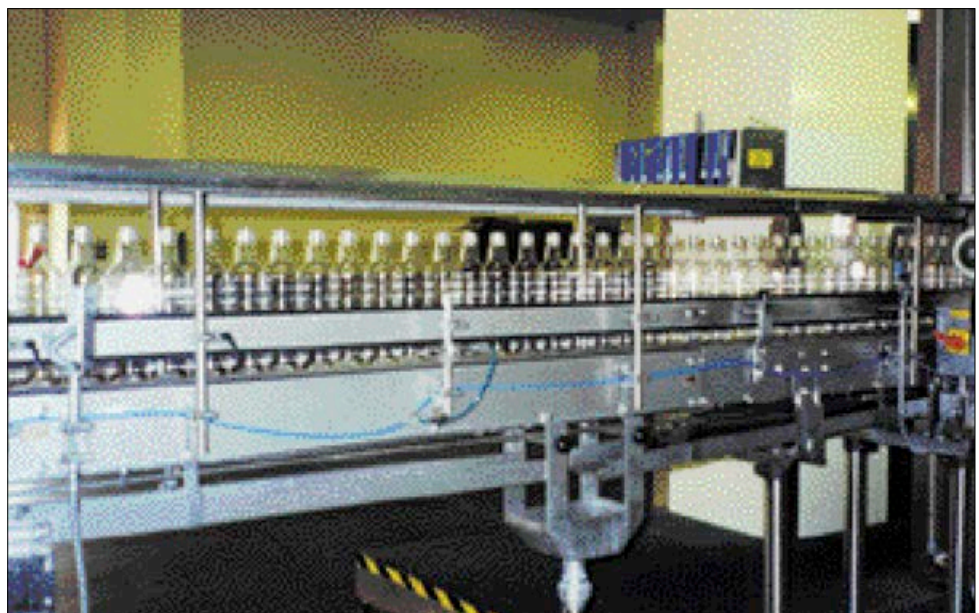
As part of bringing in a new machine, the laner mechanisms were changed to include guide-rails that moved the bottles into lanes. This change resulted in no additional cost.

*Solution: new machine fitted with guide-rails in laner mechanism*

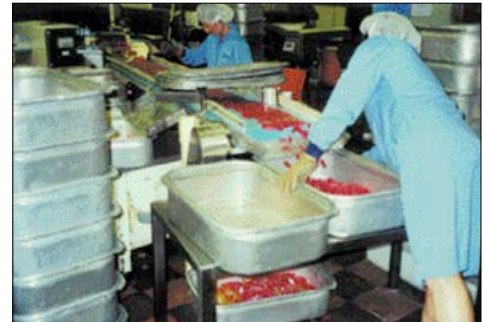
*Problem: sweets dropping into metal trays causing noise*

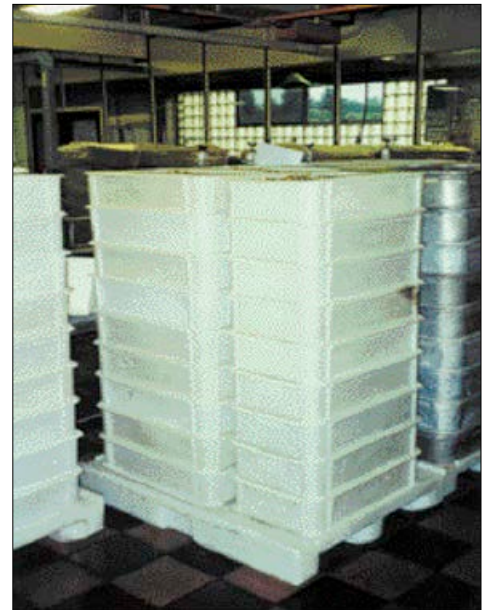
The company replaced the metal trays with trays made from high-density plastic.

*Solution: plastic trays now used to reduce noise*

- Noise levels in this section were reduced to 84–85 dB.
- The trays were lighter for the operators to handle.
- Risk of metal contamination was eliminated.

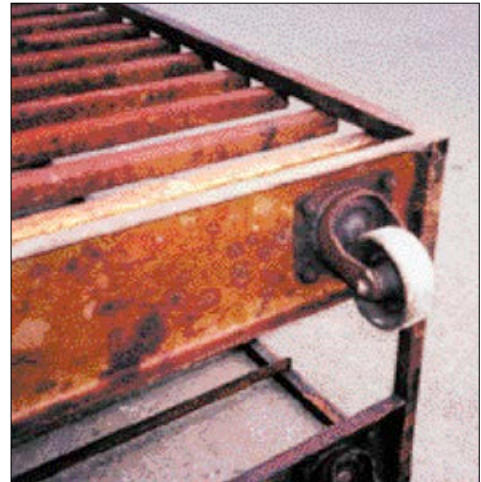
*Problem: rack fitted with original metal wheels*

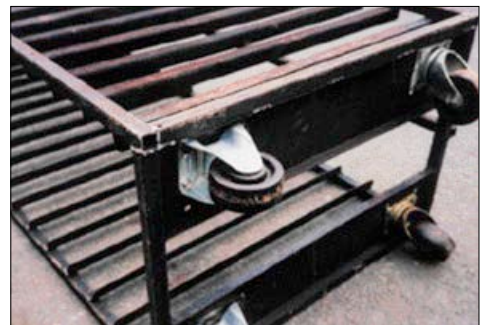
The company replaced the metal wheels on the baking racks with phenolic resin wheels.

*Solution: rack with new phenolic wheels*

- The intermittent noise levels within this area were reduced to 86–92 dB.

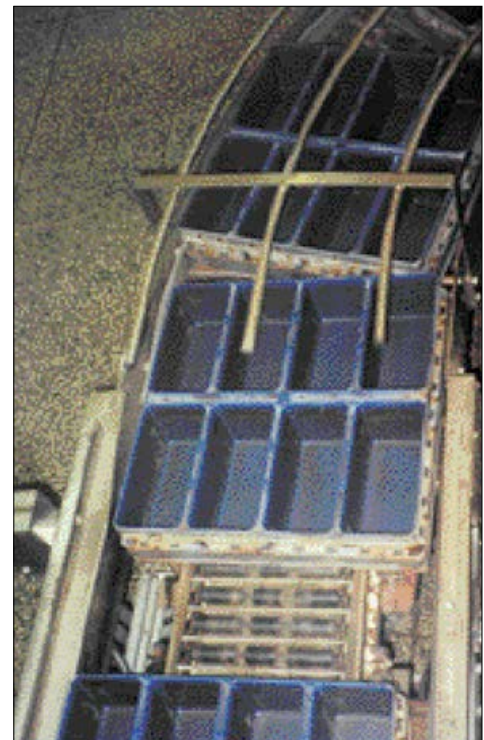
*Solution: new conveyor fitted with freely rotating rollers (visible between blue tins)*

- General noise levels from this source were reduced to below 85 dB.
- There were significant reductions in tin and conveyor wear.

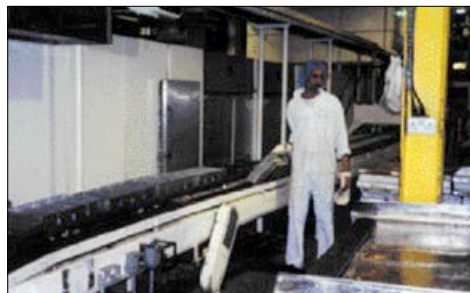
*Problem: manual tin changing*

Manual tin changeover produced noise levels in excess of 94–96 dB for the two-hour duration of the changeover. Noise was produced by:

- old tins being lifted from metal slat conveyors and dragged across conveyor side-guides;
- impact of old tins being placed on tin racks;
- impact of new tins being positioned on conveyor side-guides prior to placement;
- impact of new tins being placed on metal slat conveyors.

The operation also presented manual handling risks and resulted in excessive wear and damage to tins and conveyors.

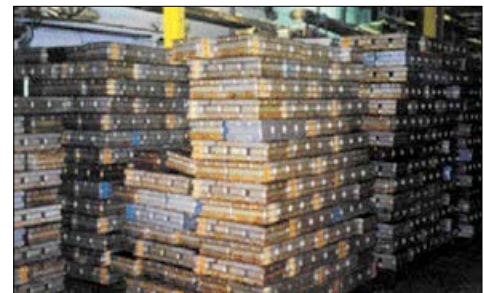
*Problem: manually stacked tins*

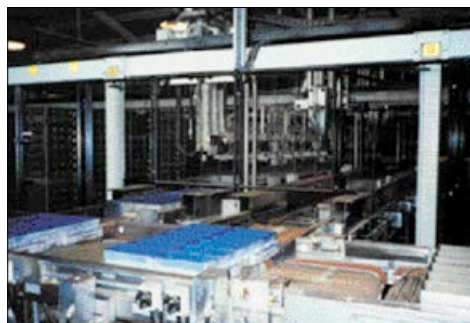
*Solution: new robot installed to change tins*

The company installed robots to remove the tins from the line and feed on new tins in accordance with product type. The system also incorporated a tin store eliminating the use and manual loading of tin racks.

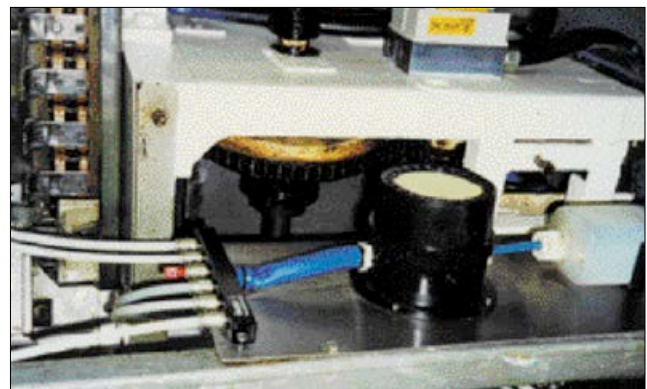
*Solution: new, quieter water pump*

- Noise levels were reduced to 84 dB.

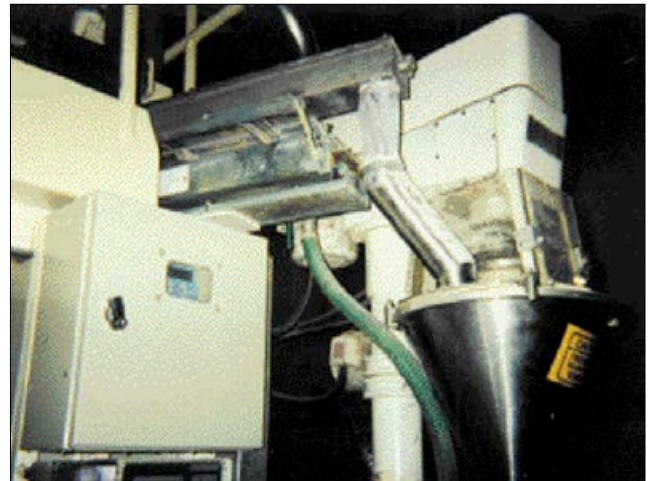
*Solution: new design of horizontal powder-feeder*

The combination of solutions resulted in such a decrease in noise levels that the company removed the hearing protection zoning from this area. The company was also able to simplify the guarding design to make both operation and servicing easier. Over a 12-hour shift, with the new arrangement, operators were exposed to only 80 dB.

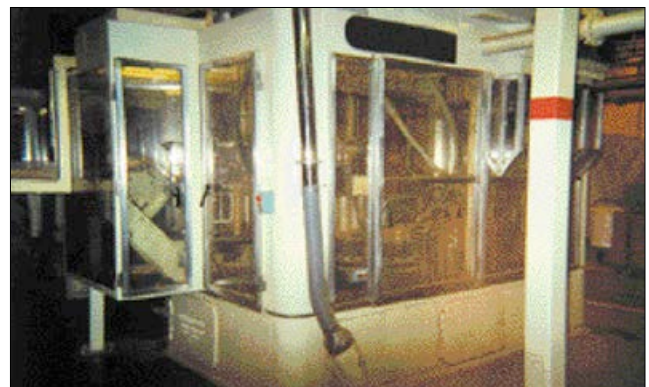
*Solution: new sealed enclosure for cup-filler machine*

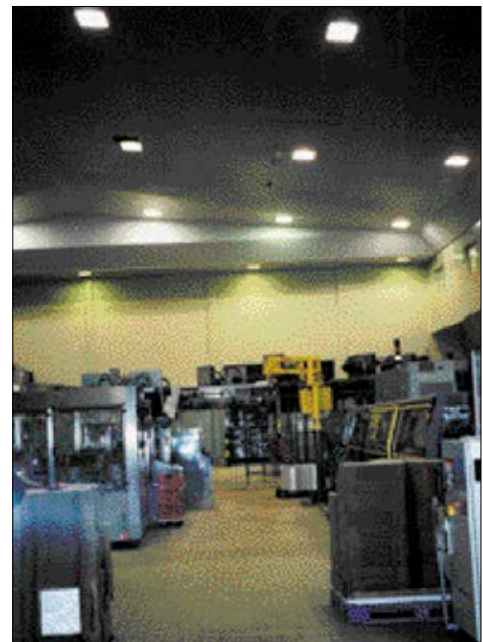
- acoustic panels on the walls (previous constructions had not included this);
- removal of stainless-steel 'droppers' for services (previous constructions had over ten stainless-steel droppers per bay which increased reverberation);
- high ceiling to reduce reverberant sound levels.

*Solution: new design of building with high ceiling and acoustic wall panels*

- Noise levels in the hall were 83 dB.
- Communication in the area was improved.
- The area was not a mandatory hearing protection zone.
- The area was a benchmark for future developments.

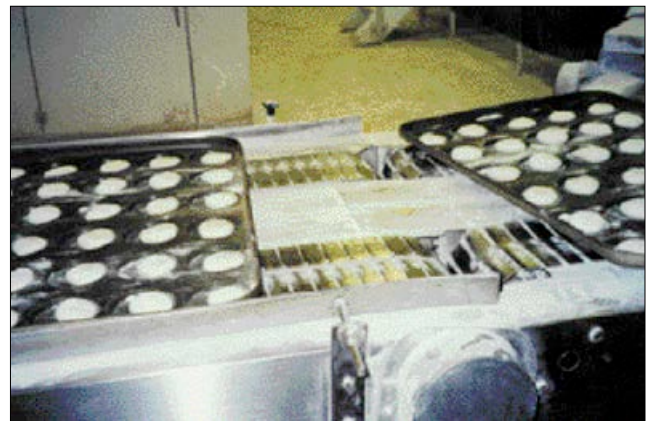
*Problem: original metal track conveyor*

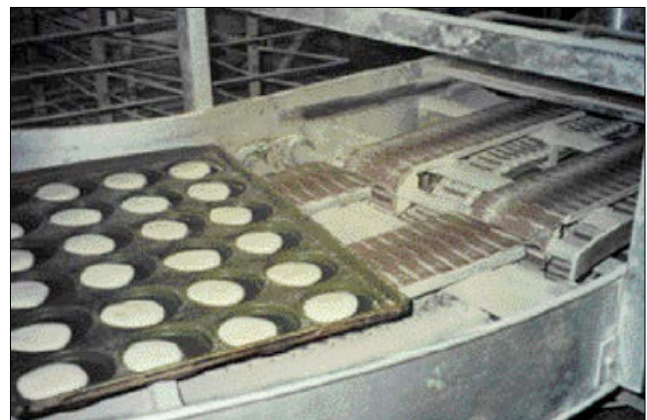
The metal tracking on the conveyor was replaced with plastic (polyurethane) tracking, which was less noisy when it came into contact with metal.

*Solution: new plastic tracking on conveyor*

- The plastic tracking reduced the noise level in the area to 87 dB.
- Unlike the metal tracks, the plastic ones did not wear to produce sharp edges and therefore cut injuries to workers were reduced.
- The plastic tracks were cheaper to replace than the metal ones.
- The plastic tracks were easier to maintain.

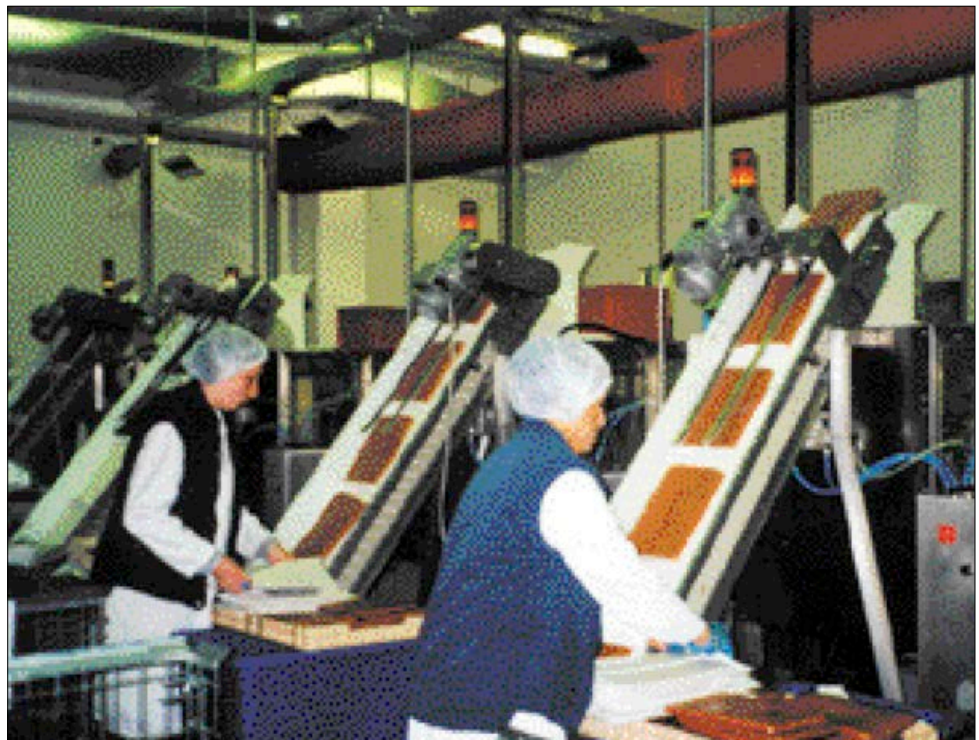
The company replaced the metal chutes with plastic chutes.

*Solution: plastic chutes for toffee transfer*

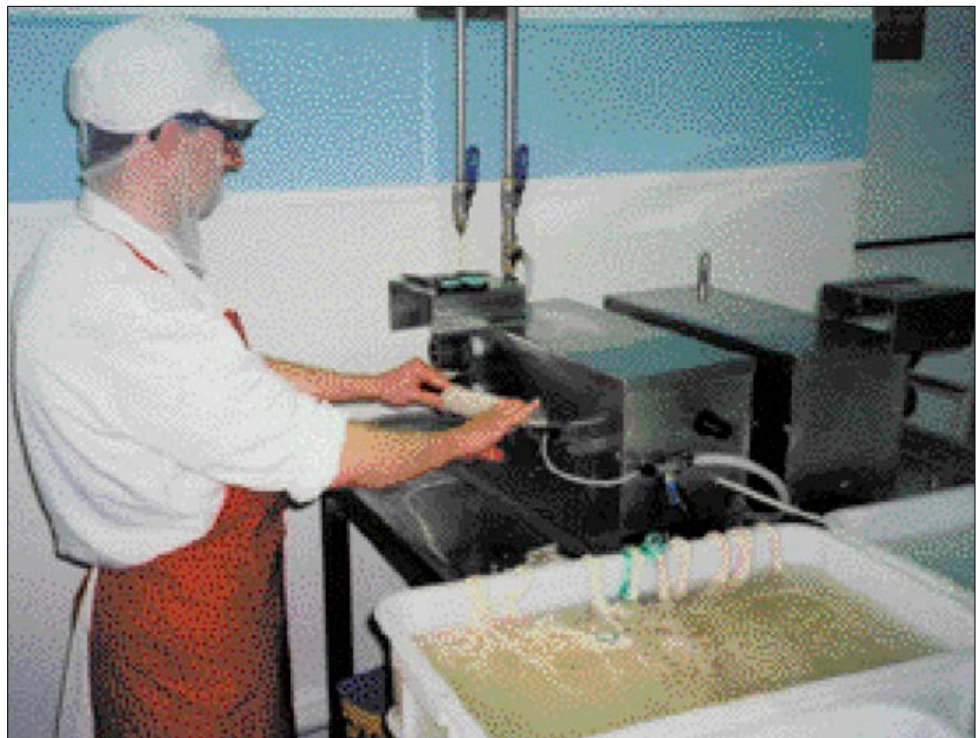
The company replaced the electric spoolers with compressed-air spoolers designed by their engineering department.

*Solution: new, quieter compressed-air spooler*

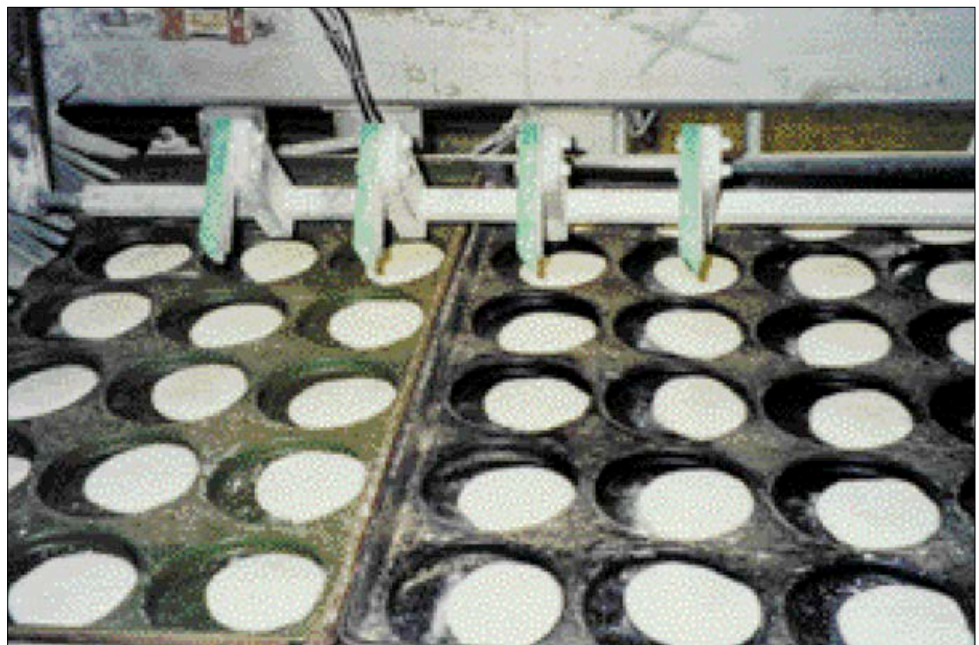
Plastic (polyurethane) caps were placed on the ends of the fingers of the indexing arm where they came into contact with the trays.

*Solution: tray-indexing arm with plastic-capped fingers*

- Noise levels were reduced to 87–89 dB.
- Damage to the surface of the trays was reduced.

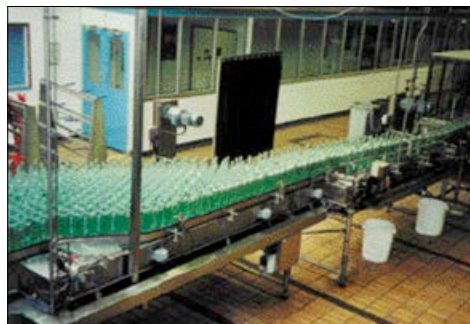
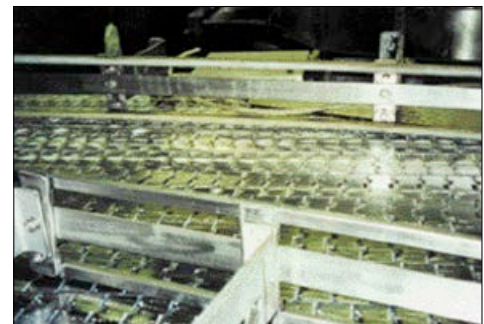
This increased control over the progress of the bottles prevented them from banging together.

*Solution: new design of conveyor and accumulation table*

*Solution: close-up of variable speed chains*

- The noise levels for the bottling line were reduced to 84 dB without enclosures.
- Staff were no longer required to wear hearing protection and were happier with the solution.
- The greater bottle control reduced bottle breakages on the line as bottles were no longer travelling under pressure.
- The efficiency of the line was increased as the bottles could accumulate at the end.

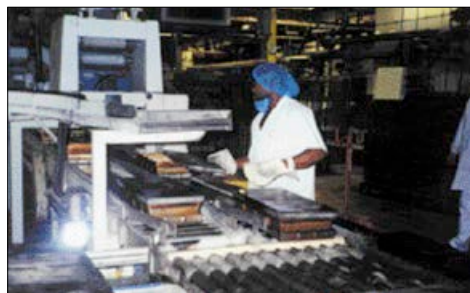
*Problem: manual de-lidding of tins*

Manual lidding and de-lidding produced noise levels typically above 90–93 dB for the duration of lidded production.

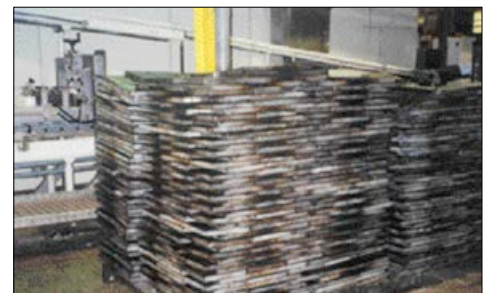
*Problem: storage of lids for manual lidding*

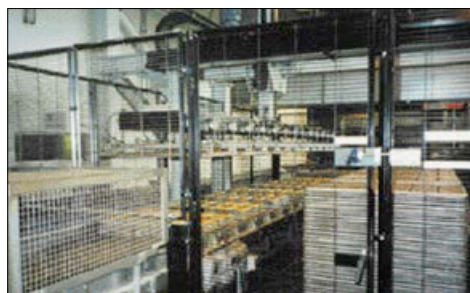
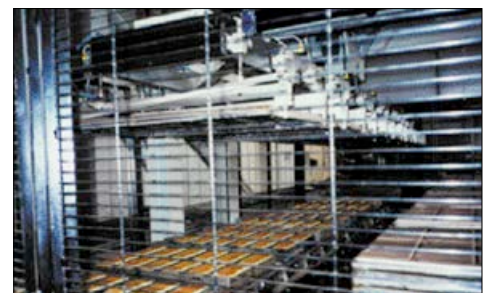
*Solution: new robot installed for lidding/de-lidding tins*

The company installed robots to remove lids from tins, convey lids to the lidding station and place lids on freshly filled tins as required. The system also utilised a lid store to eliminate rack storage and provide for controlled noise-free handling when lids were removed from the line.

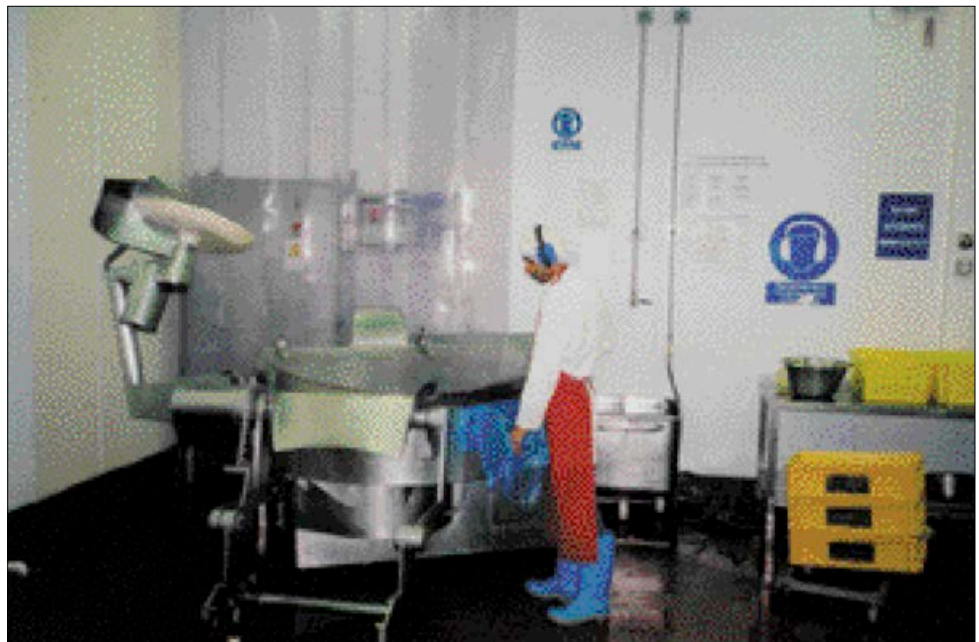
During refurbishment of the sausage production hall, the company took the opportunity to move the bowl chopper and mincers to an isolated area away from workers.

*Solution: bowl chopper and mincer in isolated area away from main production area*

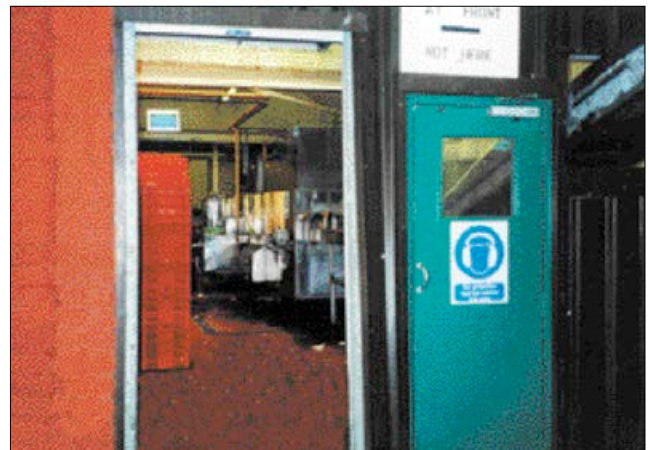
*Solution: basket-washing plant now housed in separate building*

- The general bakery staff are unaffected by the noise from the washing machine.

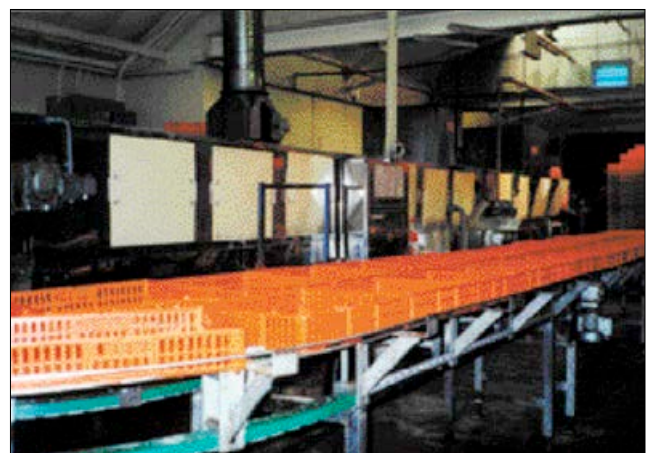
*Solution: basket-washing machine in use*

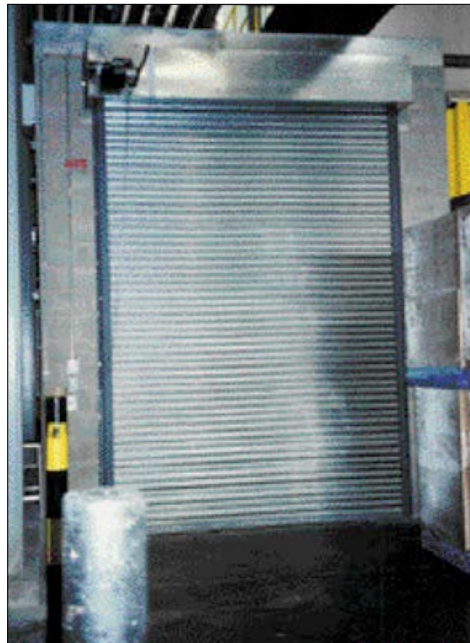
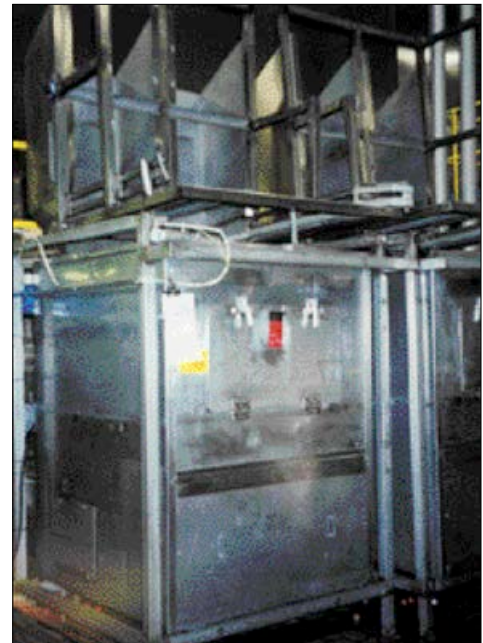
With a new production line, consideration was given to the noise levels in the working areas. The location of the cap storage and delivery systems was not critical so the decision was taken to move this process outside of the production bay into a purpose-built enclosure. The enclosure only needed to be visited three to four times per shift.

*Solution: entrance to the new segregated enclosure for cap storage and delivery*

*Solution: stainless-steel cap-hoppers inside new segregated enclosure*

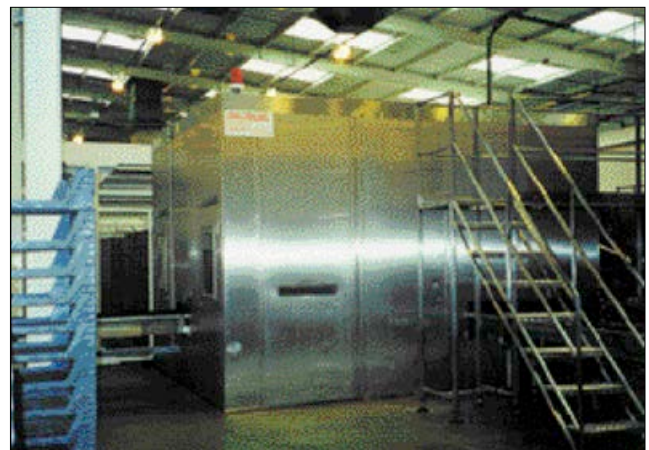
*Solution: soundproof enclosure erected around noisy plant*

*Solution: small opening in enclosure to allow entry of baking tins*

Noise levels in the bakery decreased to below 85 dB.

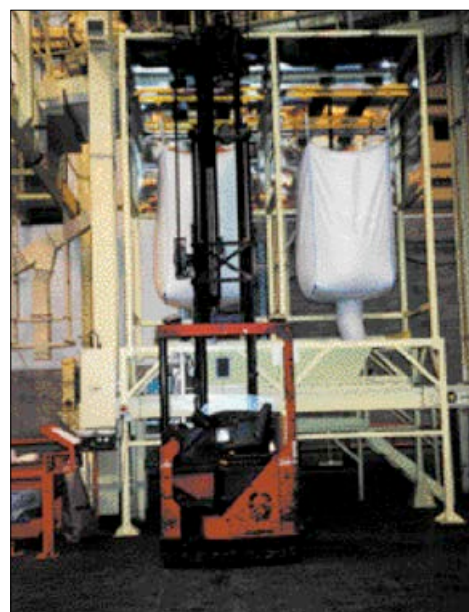
*Problem: one-tonne bag of dried food suspended above original conveyor*

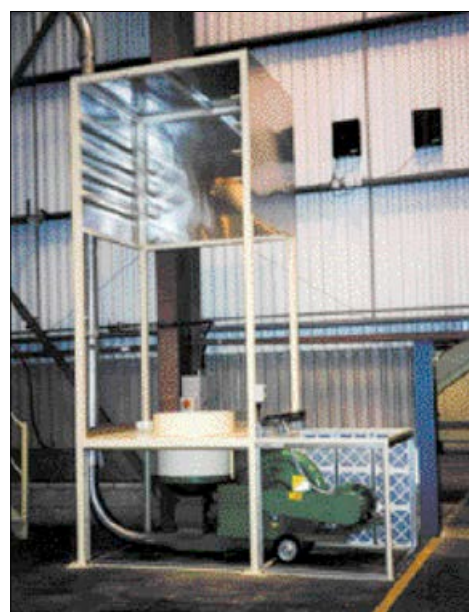
The company decided to replace the conveyor with a new piece of machinery that would transport the dried food from the one-tonne bag above to the packing machine by blowing it through metal tubing.

*Solution: new blower machine installed in enclosure (sound-absorbent side panels removed for clarity)*

- The noise levels produced by the enclosed machine were reduced to below 90 dB and the noise levels in the packing side of the factory were maintained at the same level despite the introduction of the blower machine.
- The new machine was more efficient at delivering the product from storage to the packing machine.

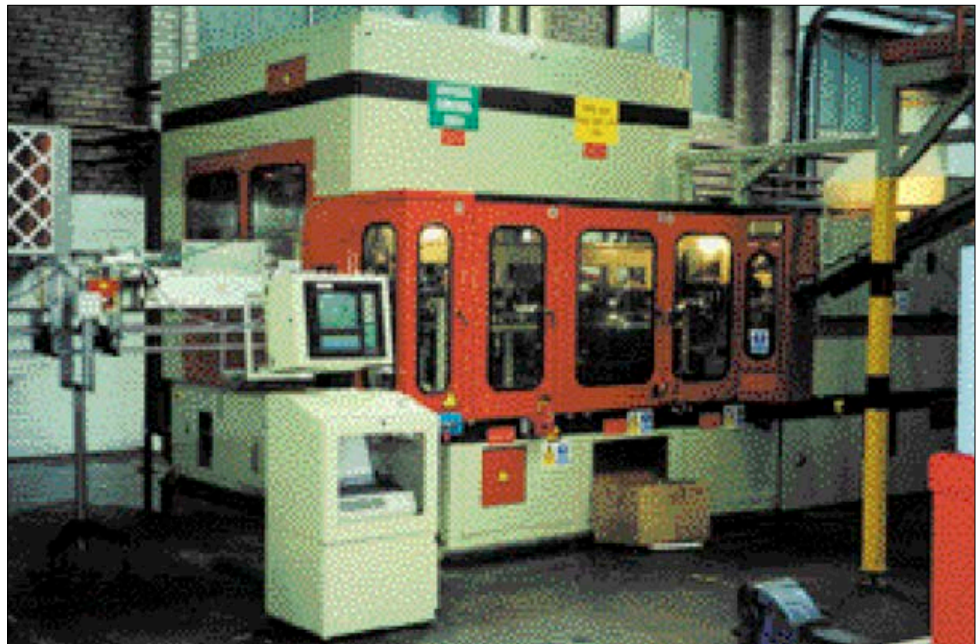
The bottle-blowing machines were the noisiest pieces of equipment in the production hall. They produced noise levels of 94 dB.

*Problem: bottle-blowing machine in production hall before being relocated in separate room*

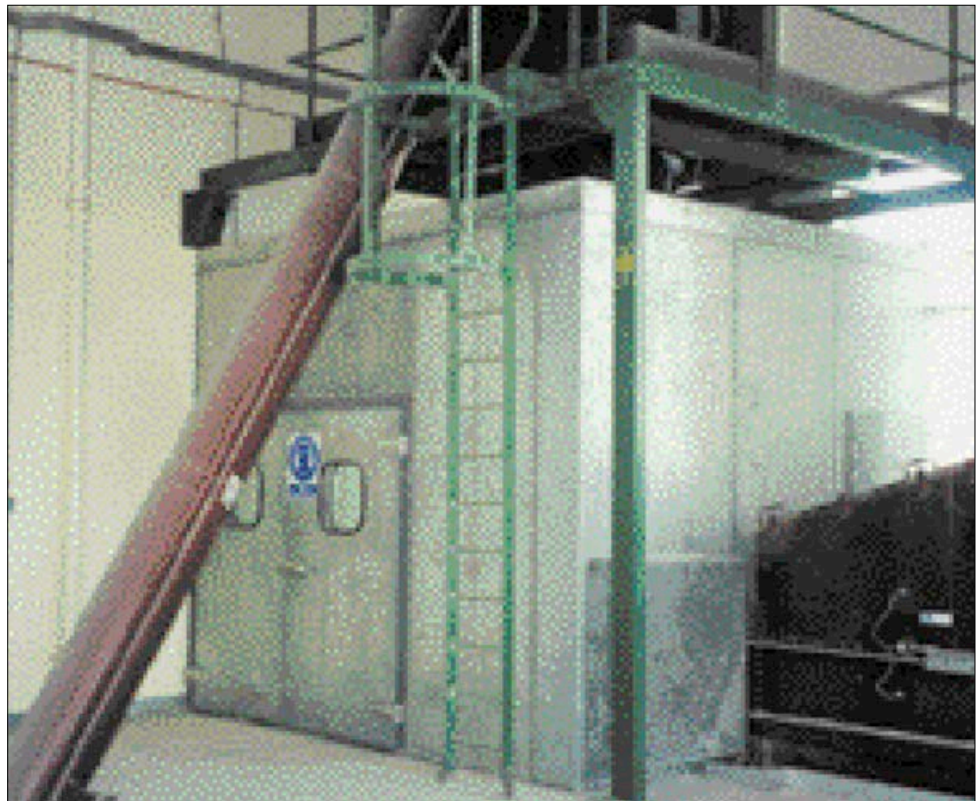
The company enclosed the hammer mill in an acoustic booth.

*Solution: hammer mill enclosed in acoustic booth*

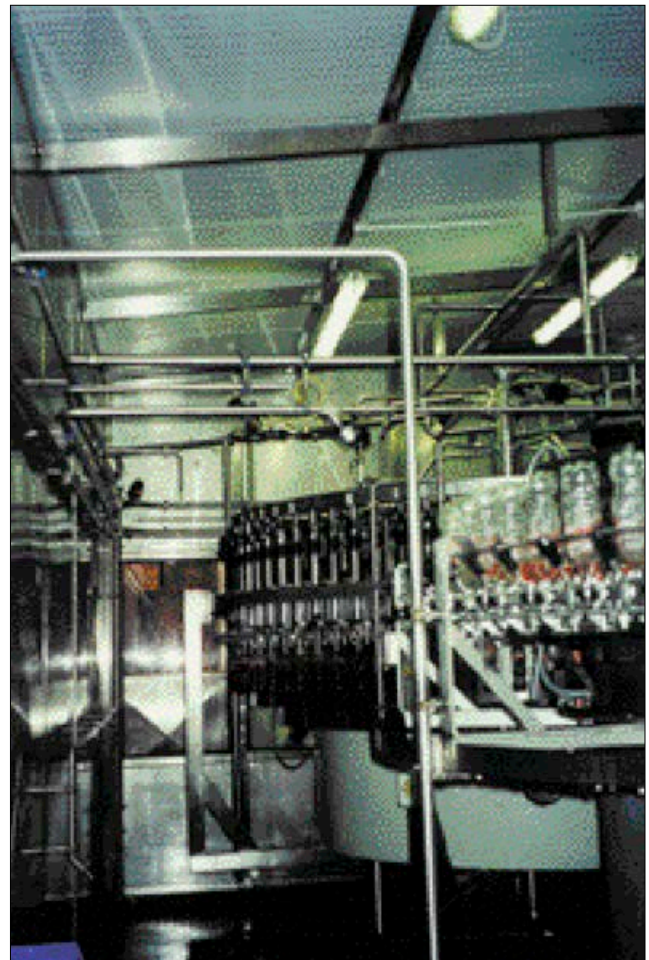
*Solution: machine enclosed by large steel frame fitted with noise-absorbent ceiling and perspex sides (photo taken from within enclosure)*

The noise levels outside the enclosure were reduced to 73 dB.

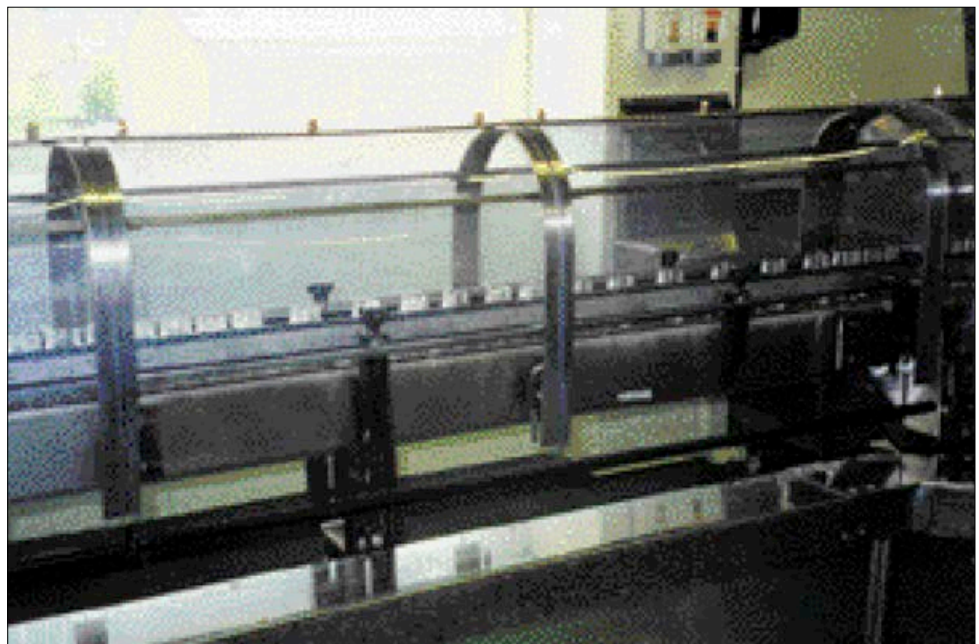
An acoustic enclosure was put over the conveyor. The company also changed the conveyor speed to reduce the amount of jar clashing.

*Problem: enclosure over glass jar conveyor*

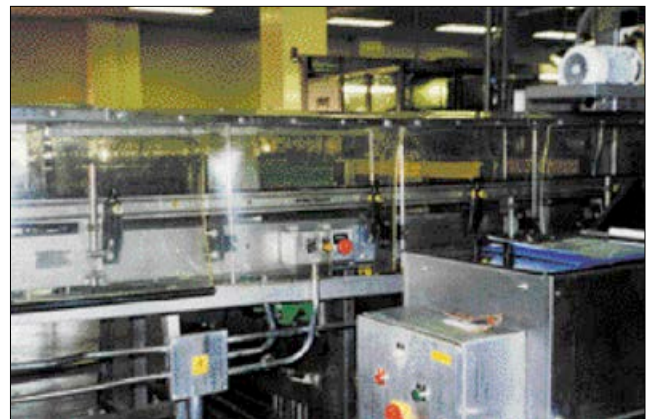
*Problem: glass-bottle-conveyor prior to enclosure*

*Solution: conveyor with enclosure fitted*

Noise levels were reduced to 92 dB.

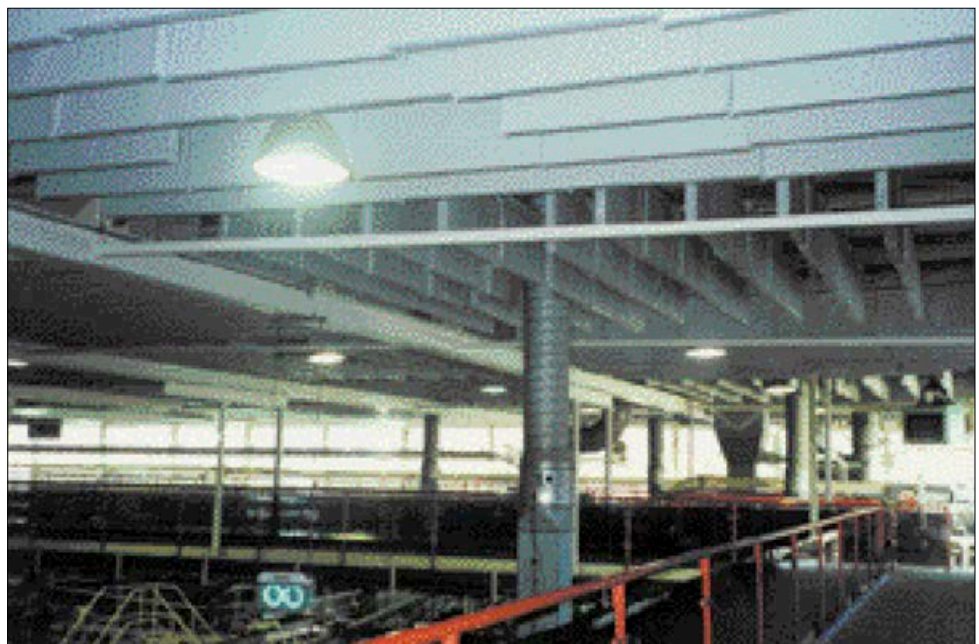
When designing the small-pack room, the company fitted acoustic baffles to the entire ceiling to prevent noise bouncing back down to the packaging lines.

*Solution: acoustic baffles fitted to ceiling*

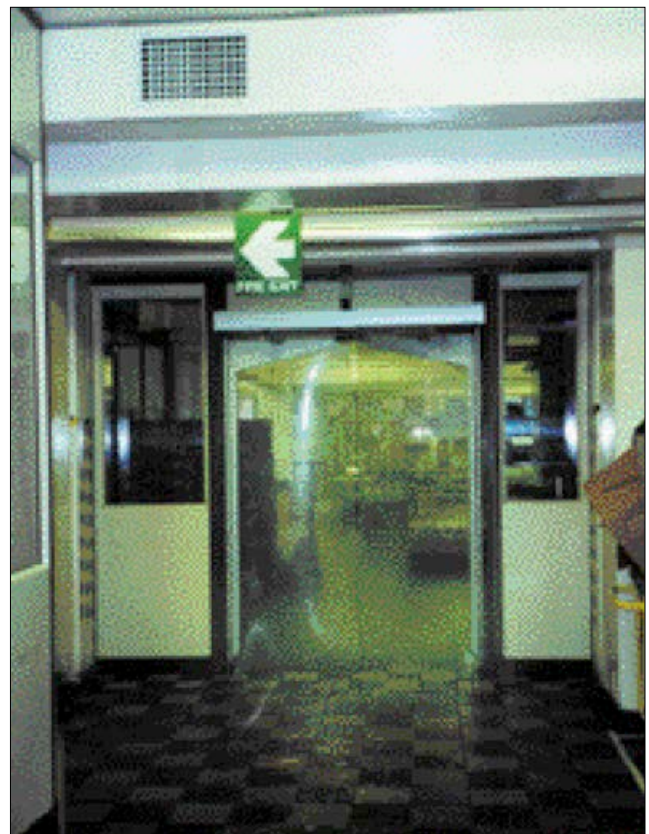
*Solution: automatic, flexible PVC curtain doors installed to segregate ear protection zone from quieter area*

- Noise was reduced in the areas that were not hearing protection zones.
- The sound-deadening properties of the walls were kept intact by the use of the automatic doors.
- The boundaries between the hearing protection zones and quieter areas were made visible.

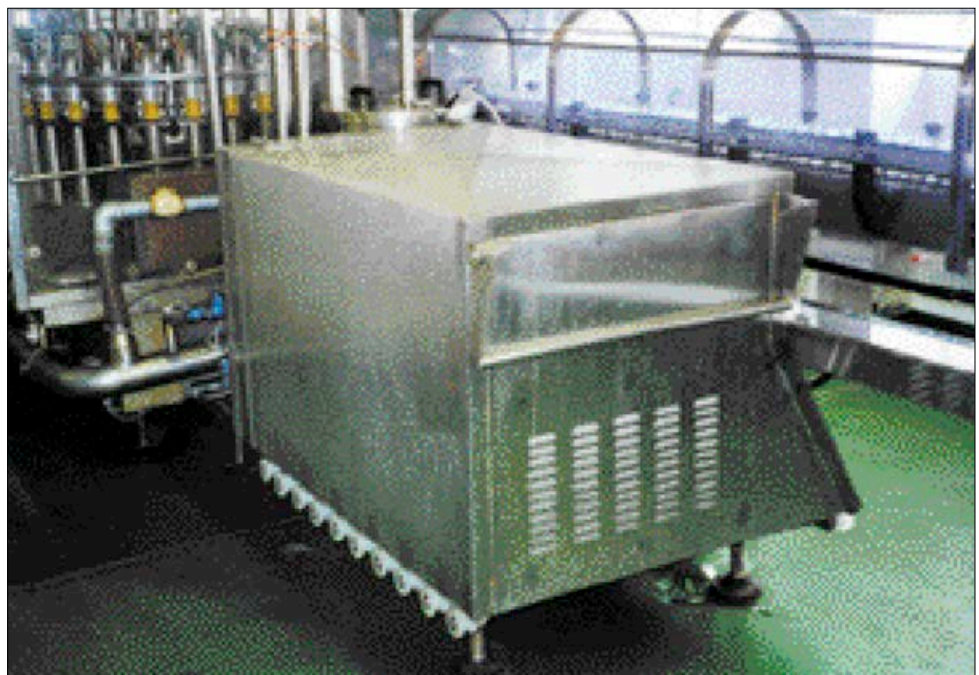
The company improved the efficiency of the pump and added an acoustic hood.

*Solution: acoustic hood fitted over filler pump*

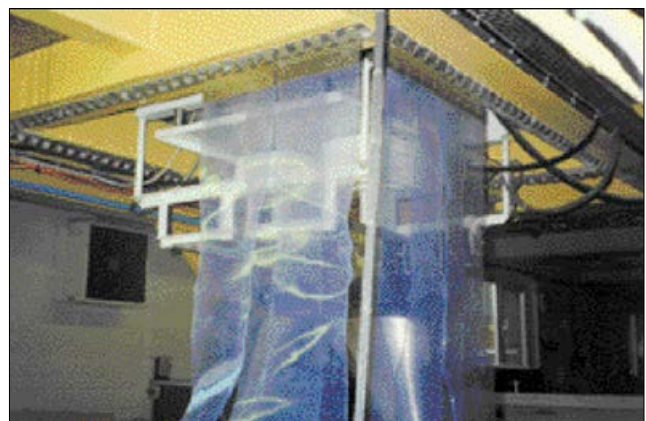
*Solution: weighing machines and hoppers with curtains removed*

*Solution: PVC curtain enclosure under construction (50% overlaps are required to be effective)*

Noise levels for the hard gum weighing and bagging process were reduced from above 90 dB to around 83 dB.

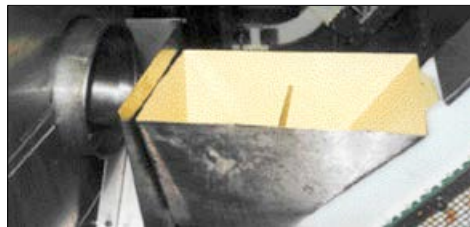
*Solution: close-up of internally coated hopper*

Noise levels were reduced by up to 8 dB.

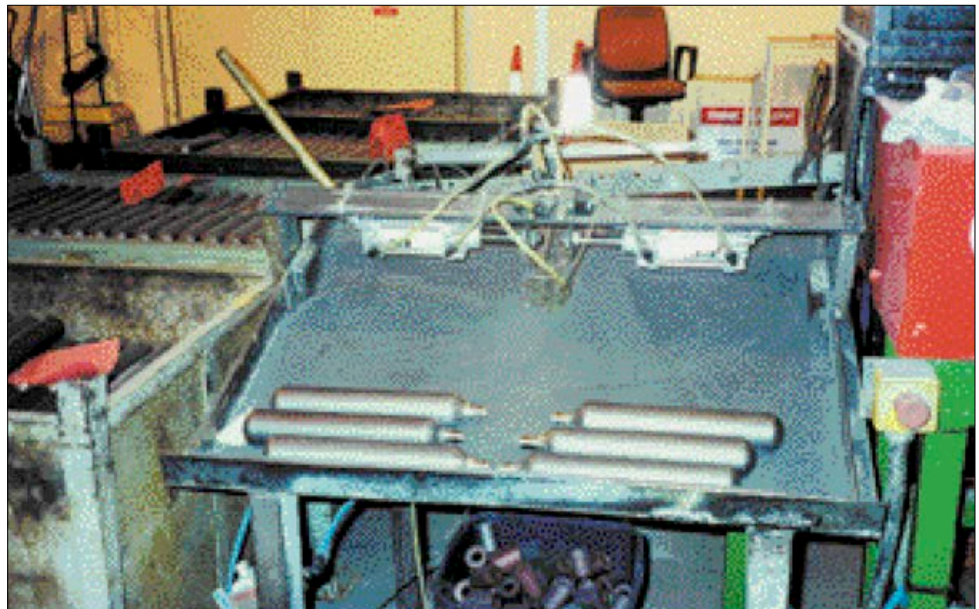
The company fixed rubber matting onto the steel-plate table.

*Solution: steel table covered with rubber matting to reduce impact noise*

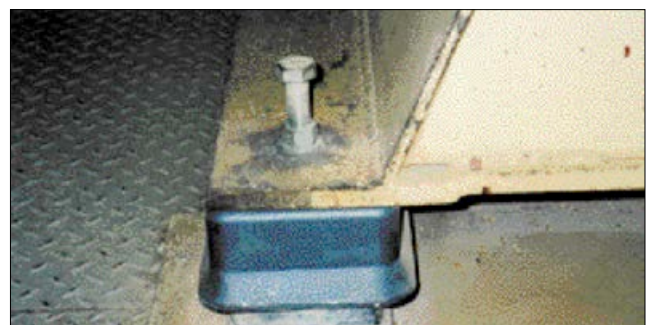
*Solution: anti-vibration mounts fitted to bottom of grinding machine*

*Solution: close-up of anti-vibration mount*

- The environmental noise was reduced to 43 dB.
- The residents of the housing estate were happier as the environmental noise levels were reduced.

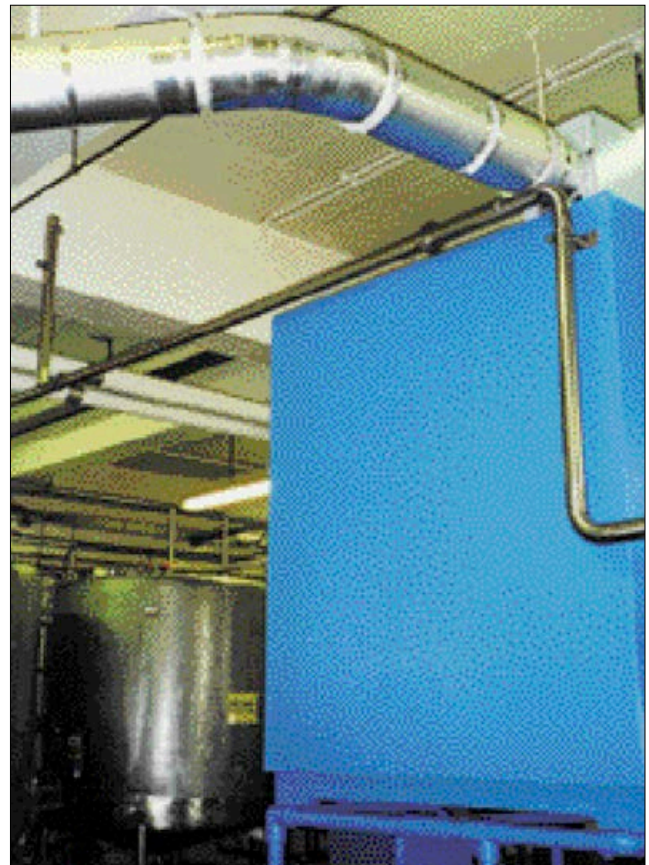
*Solution: transport ductwork (top of photo) lagged externally with noise-absorbent padding*

- Noise levels were reduced to 84 dB.
- The team no longer complain of headaches.

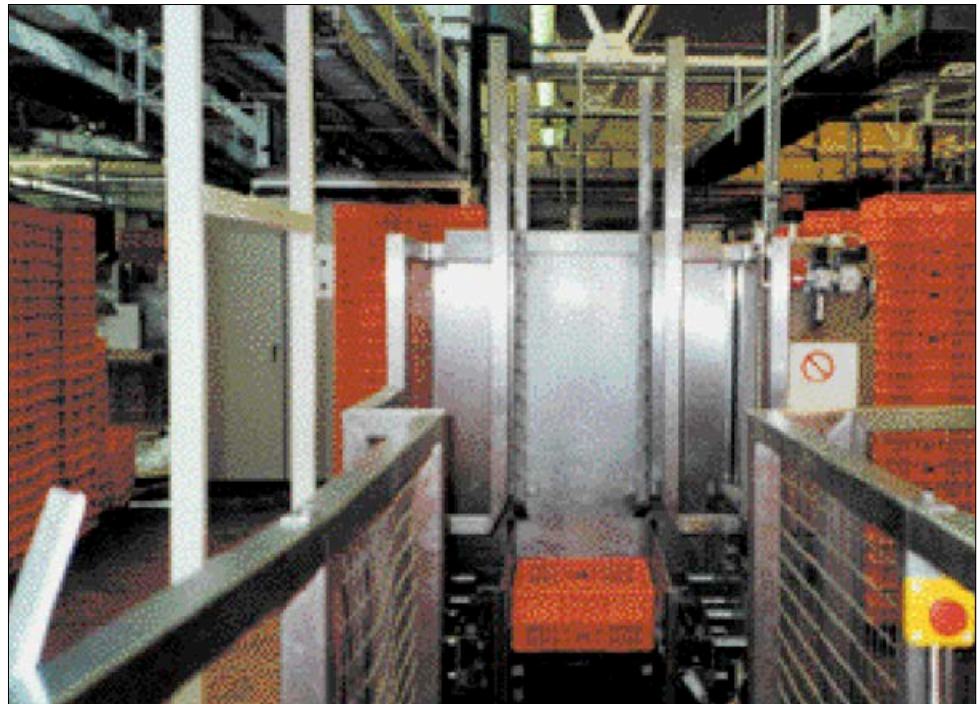
Working with the equipment manufacturers, the company replaced the hard, plastic caps on the end of the hydraulic dampers with soft, rubber caps at minimal cost.

*Solution: bread-baskets in stacking machine*

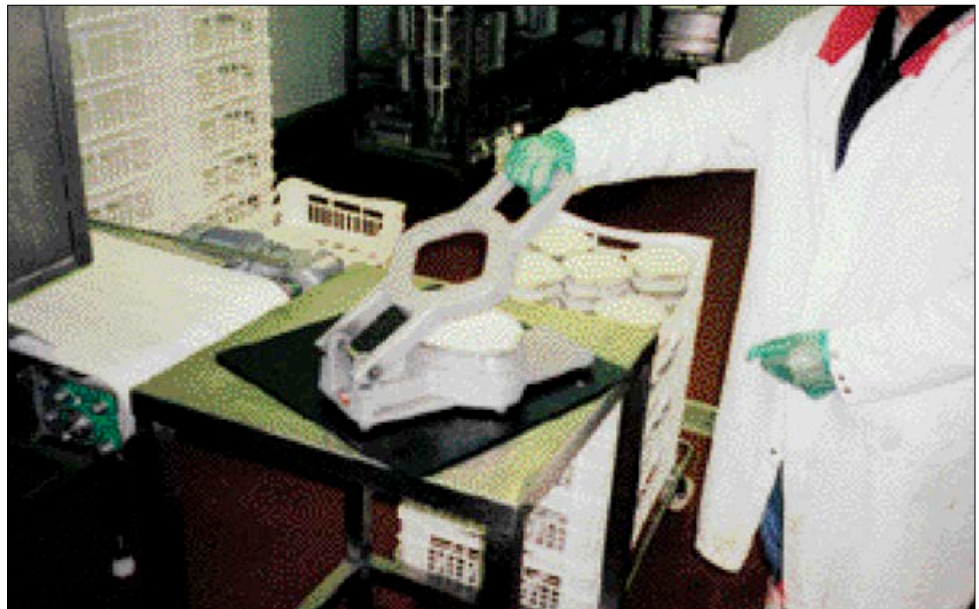
*Solution: hand-operated crimping machine mounted on layers of rubber*

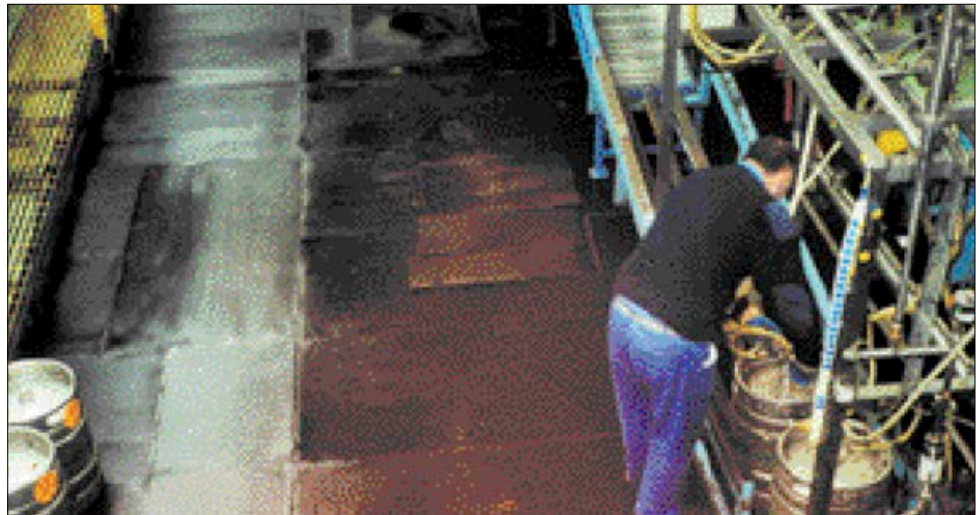
*Solution: rubber matting (black) on floor where kegs are rolled*

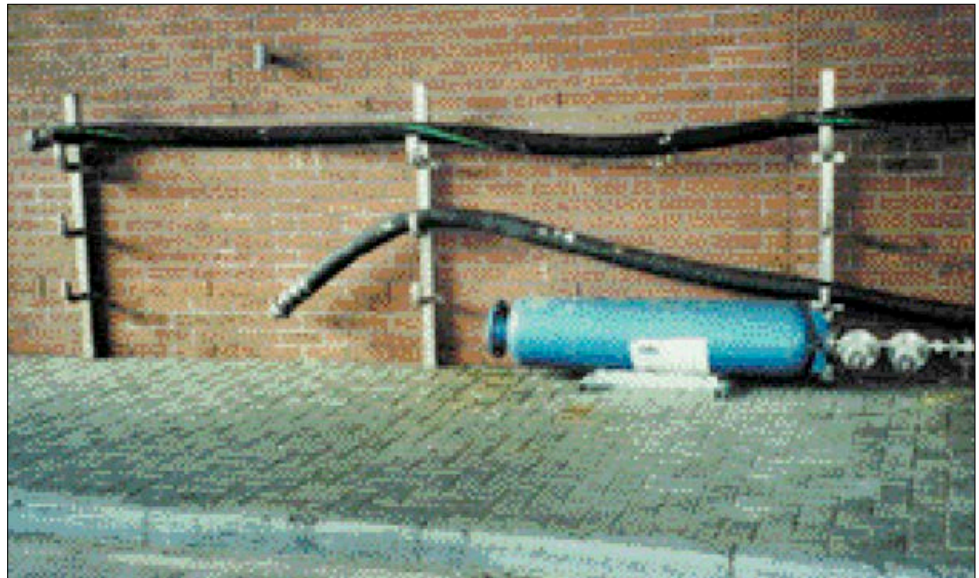
*Solution: silencer user to reduce venting noise during tanker de-gassing*
