# Sound solutions for the food and drink industries

Reducing noise in food and drink manufacturing

## **HSG232 (Second edition, published 2013)**

This book gives examples of simple, cost-effective ways of reducing the risk of hearing damage to workers in the food and drink industries. It contains 60 case studies showing how companies have found successful solutions to problems created by high noise levels.

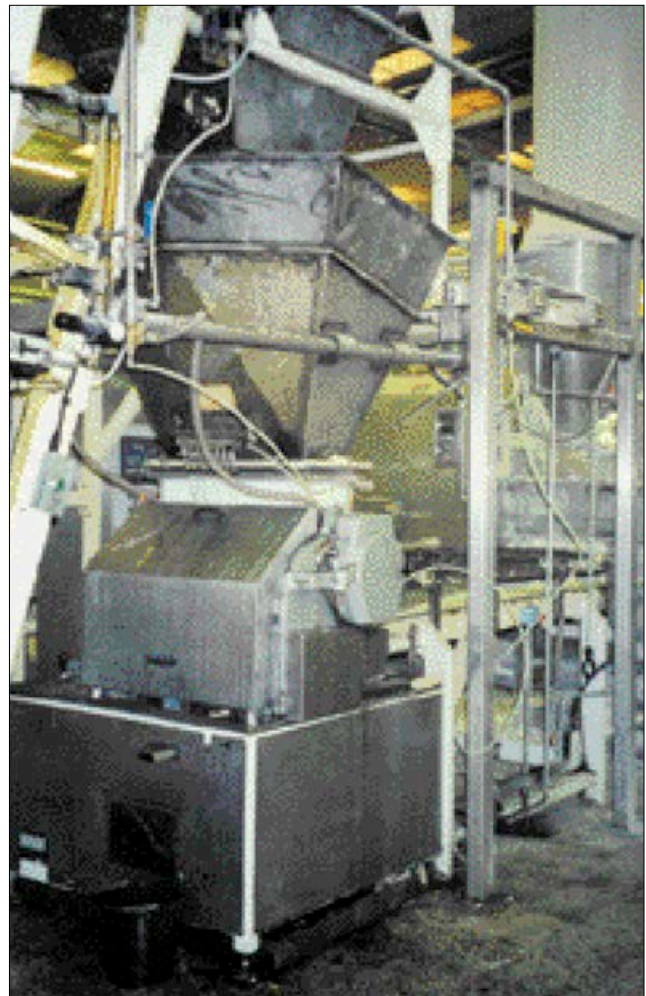
- Bearings on the machine were replaced.
- Loose panelling around the base of the machine was replaced by new, close-fitting aluminium sheeting, which resulted in less vibration and consequently less noise.
- Compressed air exhausting from the mixer was also reduced.

*Solution: mechanical modifications on dough mixer halved noise level*

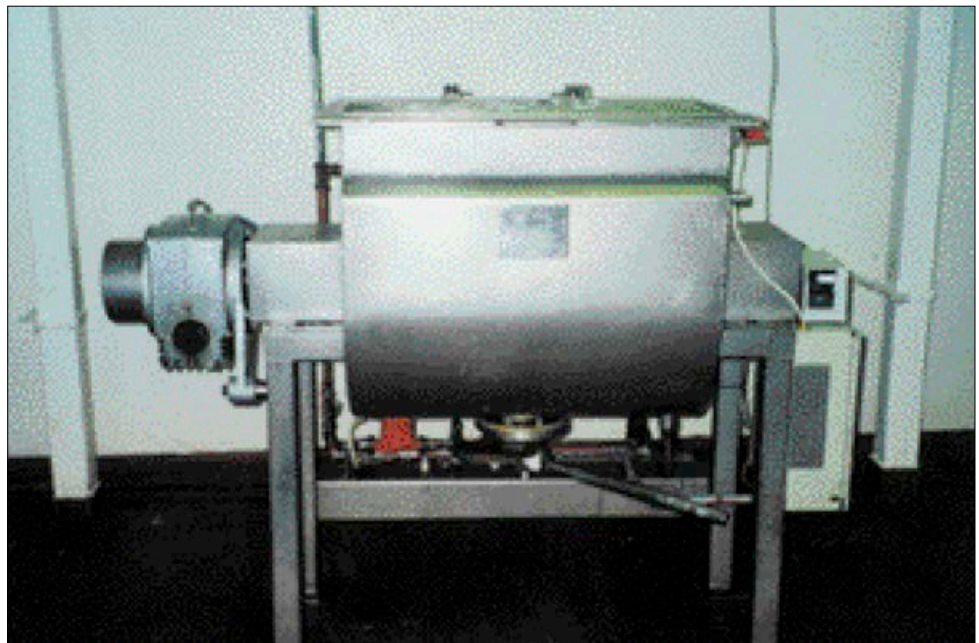
*Solution: mixing machine for fondant and chocolate*
